REDUCING SERVICE CALLS ON DROPS

BARBARA L. LUKENS

AMERICAN TELEVISION AND COMMUNICATIONS

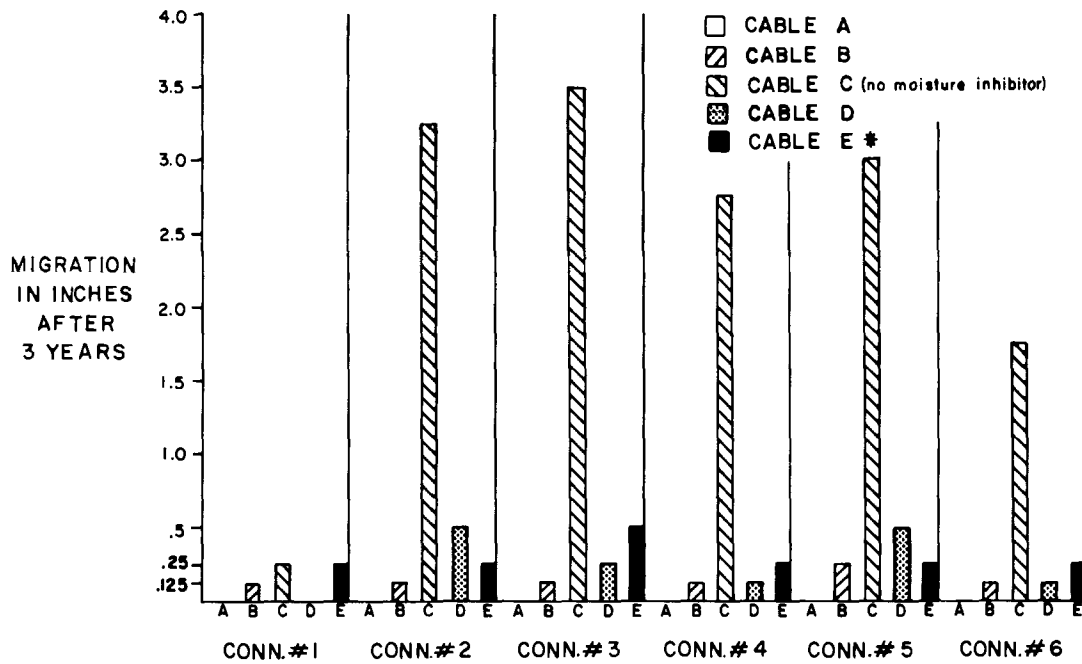
The graphs show that cable C, which is the only cable without a moisture inhibiting compound, consistently shows the greatest amount of water migration, while cable A has the least amount (usually none at all). Cables D and E allowed significantly more water migration over a seven year period than over the three year period.

* The 6th cable was added on day 7
