COST DESIGN FACTORS FOR RURAL DISTRIBUTION

FREDERICK G. GRIFFIN, P.E.

ABSTRACT

This paper describes design features for rural CATV systems, using the sub-low technology. The problem, the technology, the solution, and an example are discussed. Also covered are maintenance techniques and ingress detection procedures.

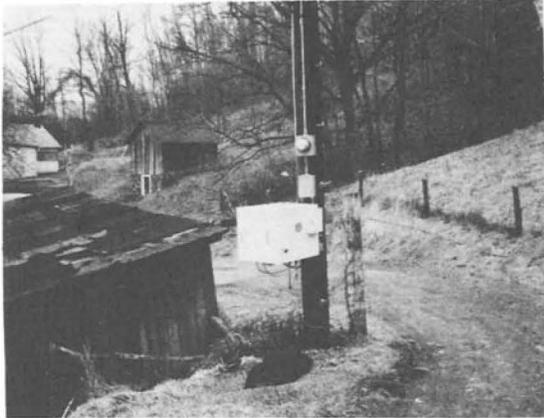
Photo 3.

The metal enclosure is a catalog purchased item from Acrodyne. This type of enclosure is typically used for television translators (Photo 3.) The box power control panel was removed and four signal processors were mounted inside. This unit comes complete with ventilating fans. The test points for the antennas were mounted on the left rack channel, and the forward and reverse test points were mounted on the right channel racks (Photo 4). It was found that more stable performance was achieved by placing an attenuator in the outgoing path, such that the signal processor operated near their typical head end design levels rather than a substantially reduced level.

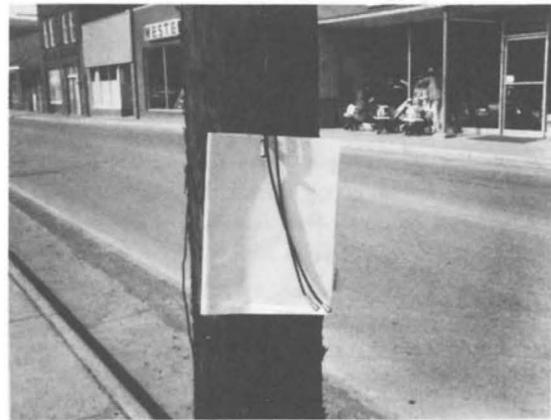
Photo 6.

A second level of detection for sub-low integrity was a relatively inexpensive battery powered short wave receiver (in the \$50 range). This is used by jacking in at a pole drop and tuning to either carrier and then unplugging to see if there is still an audio signal in the receiver (Photo 6). The banding strap at the end of the lashing cable is a good place to find an area of non shield integrity, then track either way to the egress fault source.
