Water Can Run, But It Can't Hide

PNM Finds Soaked Cables

A Technical Paper prepared for SCTE by

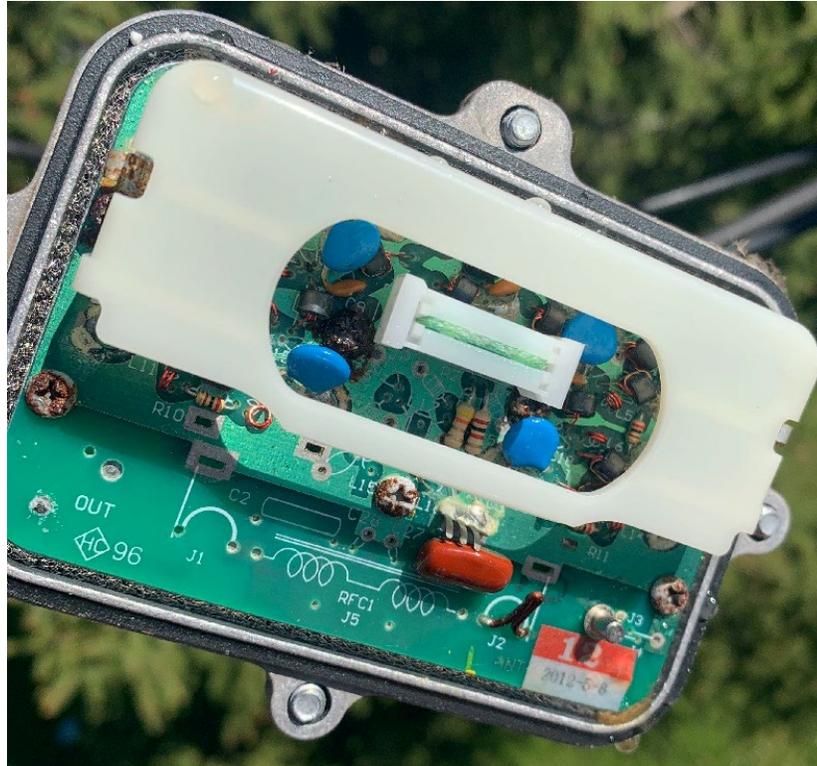
Figure 4 - Water-soaked tap faceplate, water droplets visible
 (Courtesy of James Medlock, Akleza)

In the following example, a water-soaked drop was the primary source of water ingress. However, the tap was physically located at a lower elevation on the pole than where the water entered the cable. With water accumulating over time and the influence of gravity, the water eventually migrated into the tap. A closer look at Figure 4 clearly shows water droplets in the upper left and lower right corners of the tap faceplate. The circuit also shows rust and other signs of corrosion. The subsequent frequency responses were captured before and after the faceplate was replaced. The FBC spectrum in Figure 5 represents a typical high-frequency roll-off starting around 500 MHz, becoming dramatically worse at 750 MHz (nearly 30

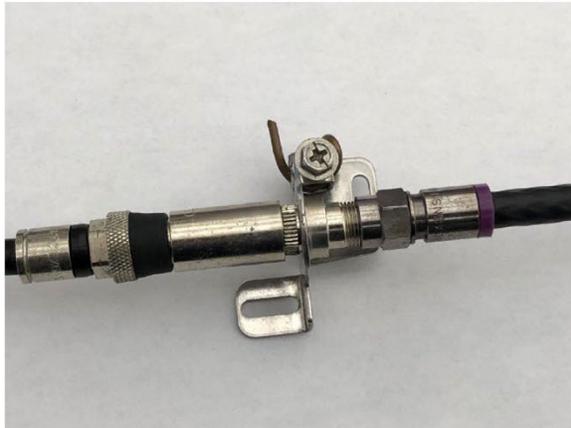
Housing separated

Figure 7 - MoCA filter housing separation

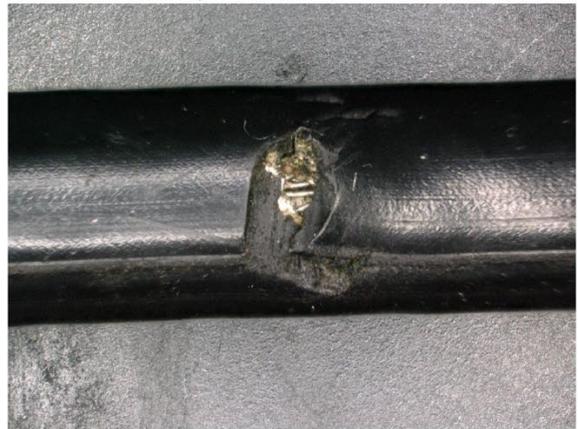
Close up view of breach

Figure 8 - Coaxial jacket breach near tap-side connector

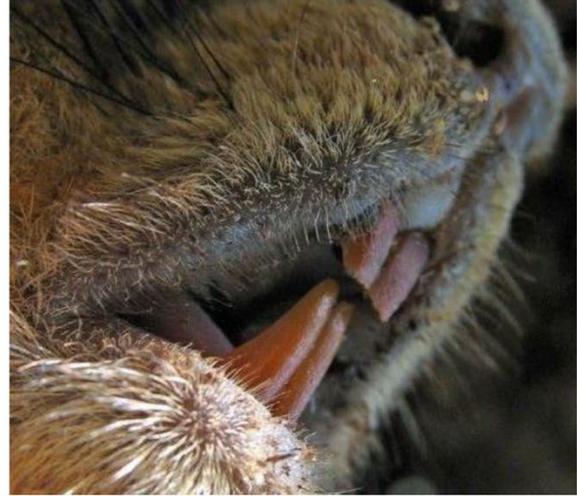
Figure 9 - Jacket breach compared with rodent teeth

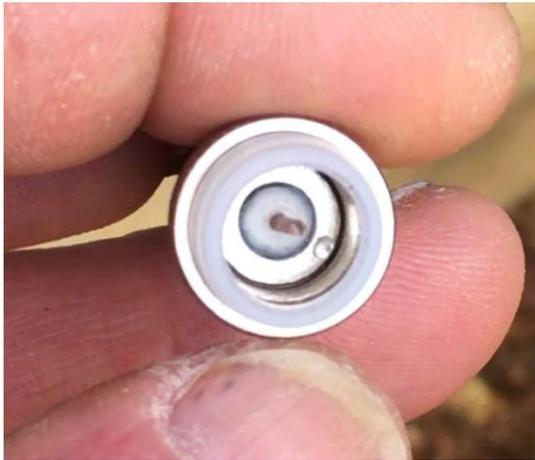
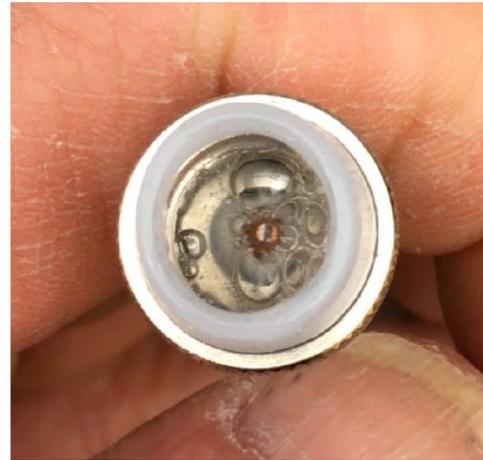
Same connector after a vacuum pulled.
Demonstrates drop is saturated

Figure 10 - Water visible after vacuum is applied

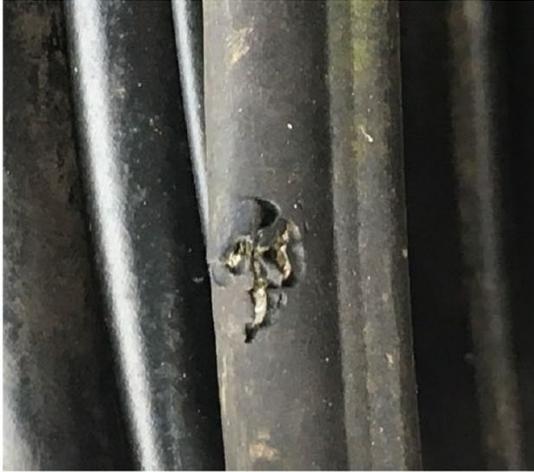
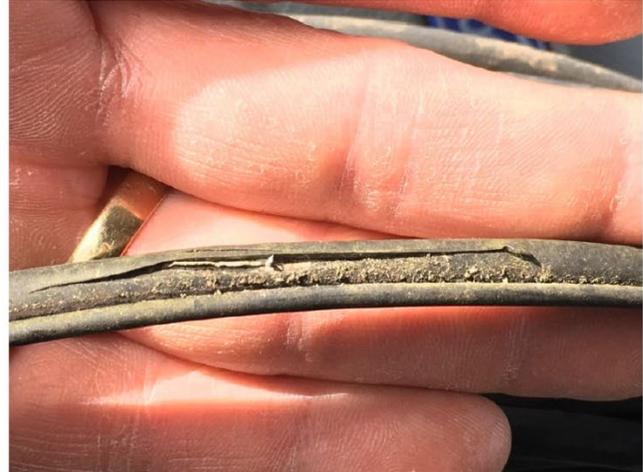
Figure 11 - Rodent chew compared to elongated cut, common coaxial damages

The condition and integrity of the outer jacket is critically important to protect the cable plant from water ingress. While evaluating several damaged filters, water ingress and freezing could readily be attributed as the cause. In each example, the water ingress point could be located. Figure 11 shows more examples of typical jacket damage.

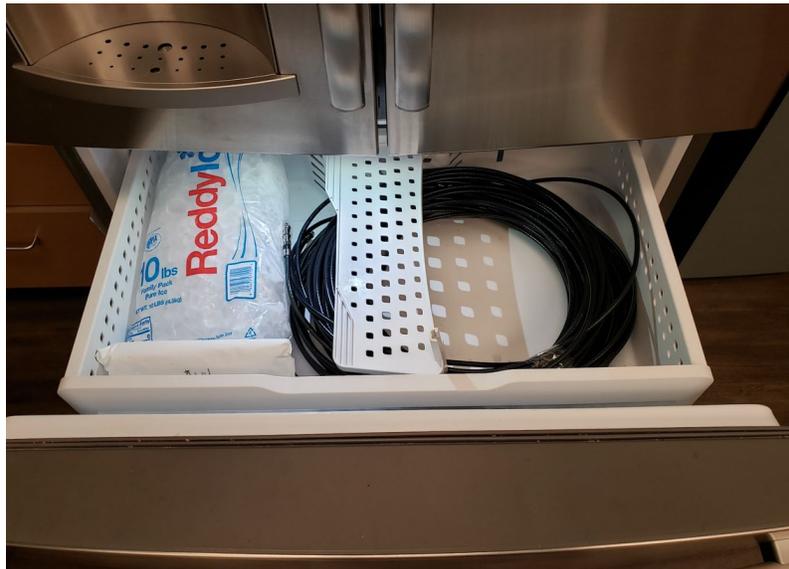
Figure 14 - Freezing the water-soaked drop cable

To examine the influence of temperature, the same damaged cable was frozen (Figure 14) at -10 degrees Fahrenheit. After freezing, the frequency response was measured (Figure 15) and the attenuation greatly improved, having well over 25 dB improvement at certain frequencies.

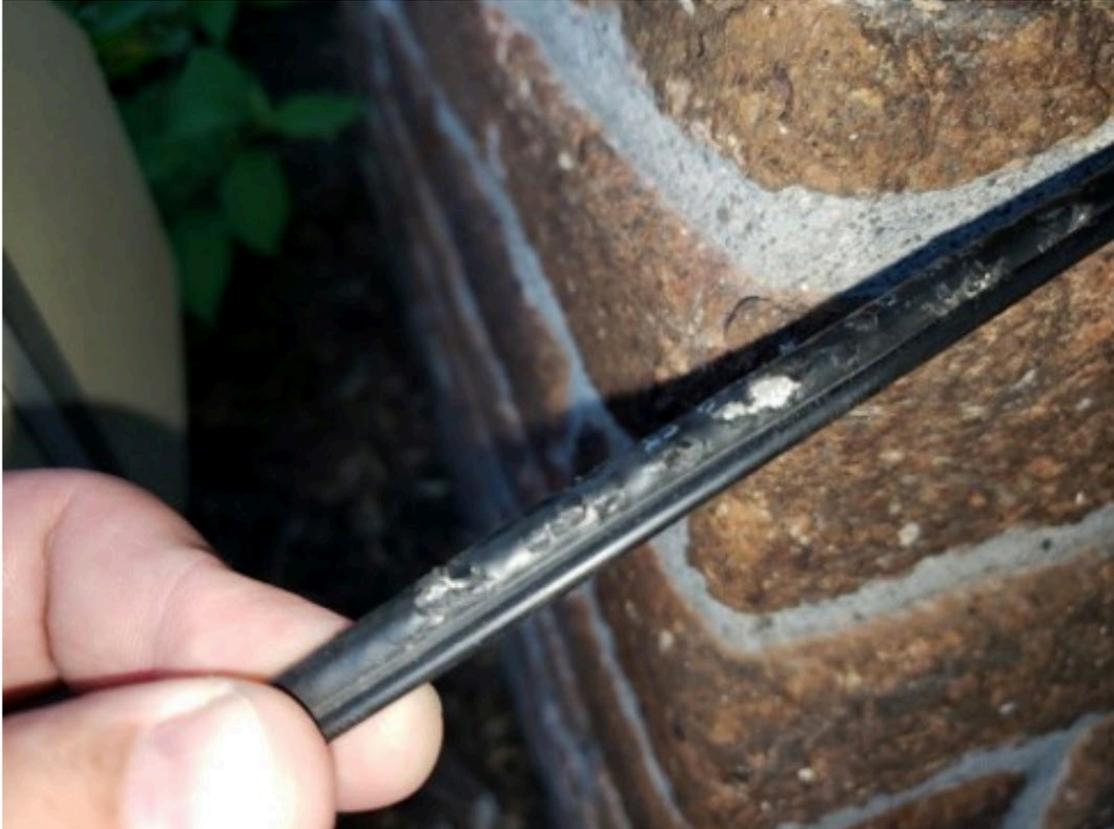
Figure 19 - Damaged coax jacket where water was able to enter the cable

Technicians went to the subscriber location and were able to find and fix the problem without having to enter the premises. Figure 19 shows the coax jacket, which had been damaged by abrasion from the electrical service drop. The damaged coax jacket allowed water to enter the cable and travel inside of the cable all the way to the ground block. Figure 20 shows water coming out of the connector at the ground block end of the drop.

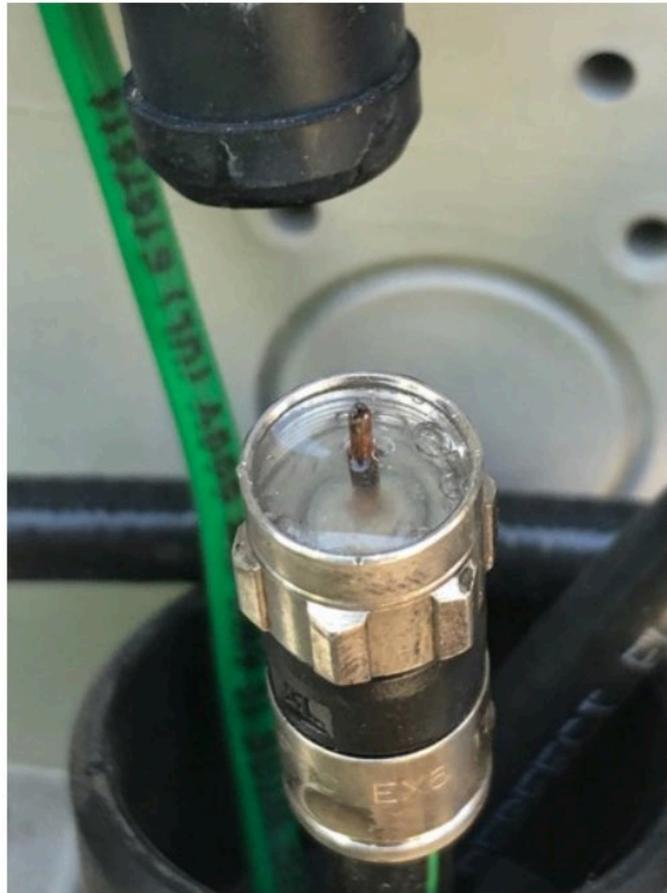
Figure 20 - Water coming out of the end of the connector at the ground block

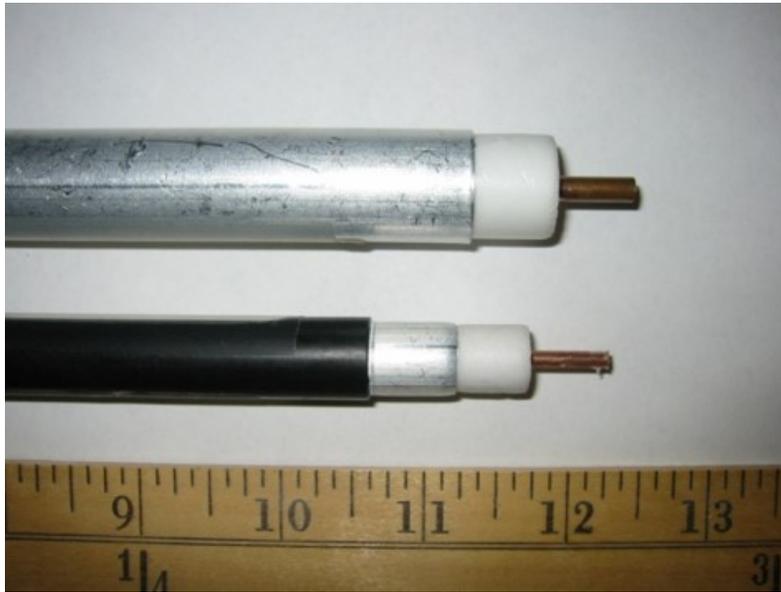
Figure 43 - Examples of hardline coaxial cable: unjacketed 0.750 inch diameter (top) and jacketed 0.500 inch diameter (bottom)

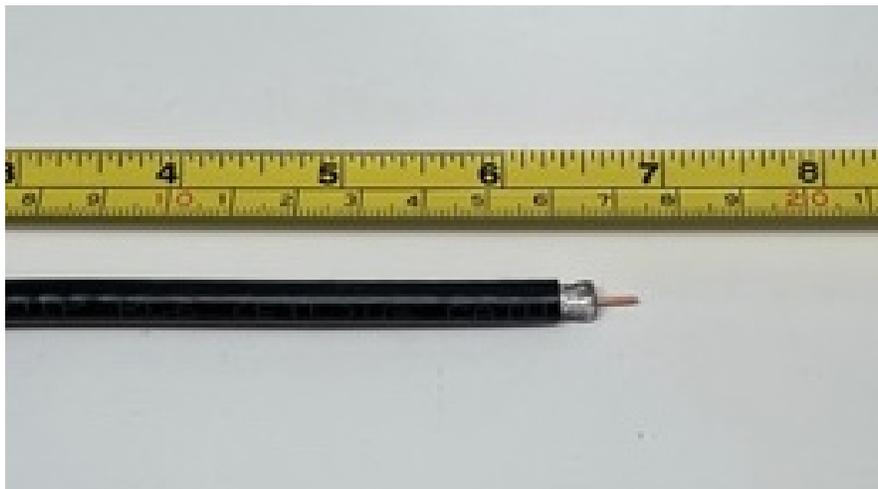
Figure 44 - Series 6 coaxial cable with the end prepped for installation of a connector

The second type is a smaller diameter, flexible coaxial cable used for the subscriber drop, which is that part of a cable network between the hardline distribution plant and the customer premises equipment inside the home. The center conductor is typically copper-clad steel, and the shield a combination of Mylar-backed aluminum tape and braid. See Figure 44.
